Manhole Inspection Summary

Manhole # S13A__035MH

Location Address: **2875 POPLAR GROVE ST**

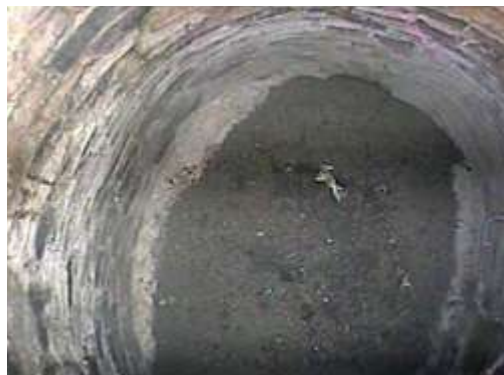
Defect 1

Count: **3** Missing: **0** ☒ **Corroded**

CORRODED STEPS

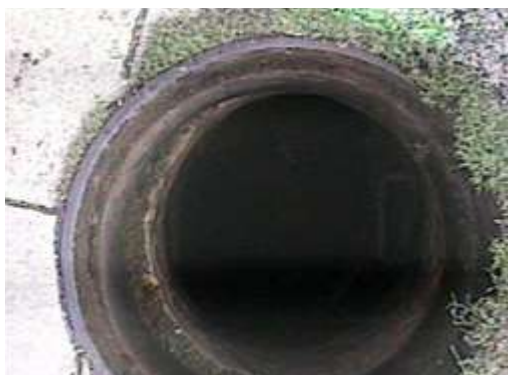
Defect 2

Offset: **2** (in.)

OFFSET FRAME

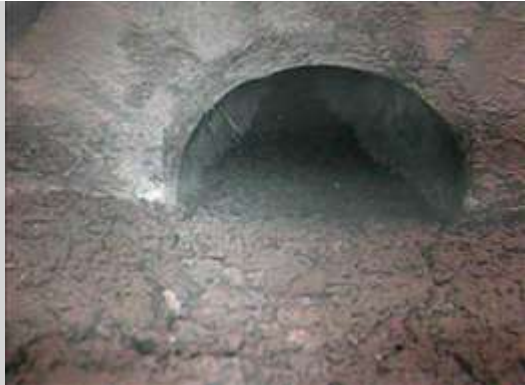
12 O'Clock Outflow

8 in. Circular Gravity Sewer
Pipe Out @ 12 O'Clock

Deposits: ☐ None ☒ **Mud** ☐ Sludge ☐ Debris ☐ Grease

Silt Depth: **2** (in.) Deposits Extent: **Light**
